A Discussion of

"Analysis of Structural Response of WTC 7 to Fire and Sequential Failures Leading to Collapse"

Journal of Structural Engineering, January 2012, Vol. 138, No. 1

Ronald H. Brookman, M.S., S.E.¹

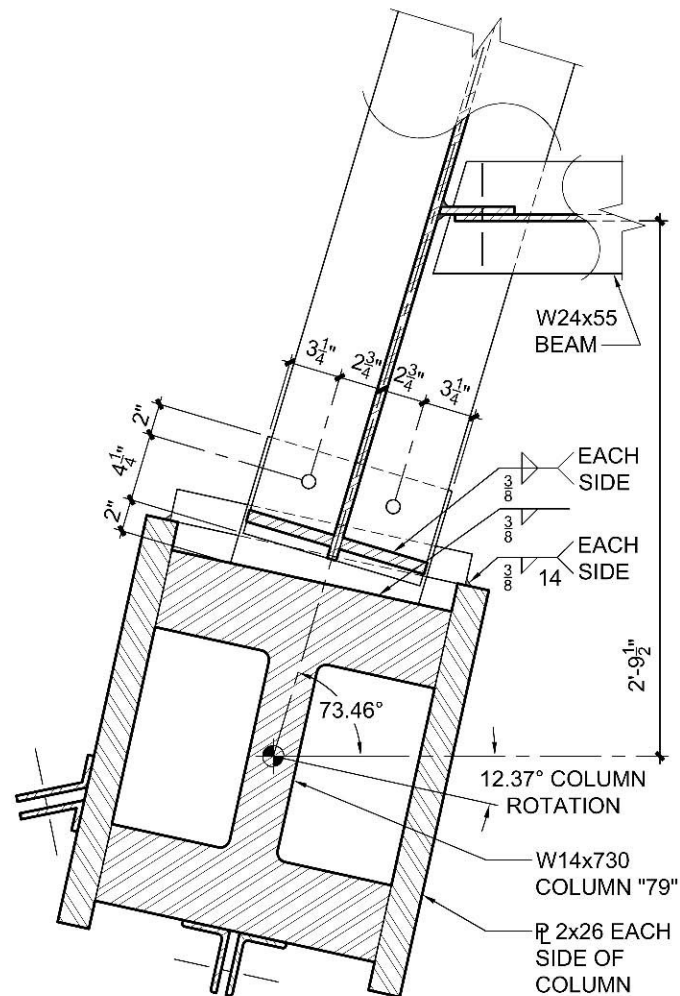
Figure 1: Plan View at Floor 13, Column 79 Seated-Beam Connection

Axial walk-off was *not* possible. The maximum vertical deflection (sagging) of the W33x130 girder was less than two inches (51 mm) due to service loads including dead load plus 25 percent of the office-floor live load, so the resulting axial movement due to sagging was practically zero. This deflection calculation includes a stiffness reduction for elevated temperature up to 1,200 degrees F. (650 degrees C.) The critical girder was also restrained from excessive axial movement between the web of column 44 (drawing 9102, Frankel Steel 1985b) and the flange of column 79 (drawing 9114, Frankel Steel 1985b). An axial displacement of 6.25 inches (159 mm, McAllister et al. 2008) leading to "walk-off" was simply not possible.

How did the NIST WTC Investigation Team arrive at a 5.5-inch (140 mm) threshold for axial "walk-off" of the girder at column 79? The bearing length at column 79 was 6.25 inches (159 mm) along the girder's axis as shown on fabrication drawings 1091 and 9114 (Frankel Steel 1985b), and the girder was restrained between columns 44 and 79.

Could "walk-off" occur with a 6.25-inch (159 mm) lateral displacement? Figure 1 illustrates a plan view of the seated-beam connection with dimensions and geometry shown to scale. Figure 2 shows the same connection in a section view through the girder. The one-inch (25 mm) thick bearing plate was 12 inches (305 mm) long and 8.25 inches (210 mm) wide at its widest point. Stiffener plates were welded on each side of the girder web.

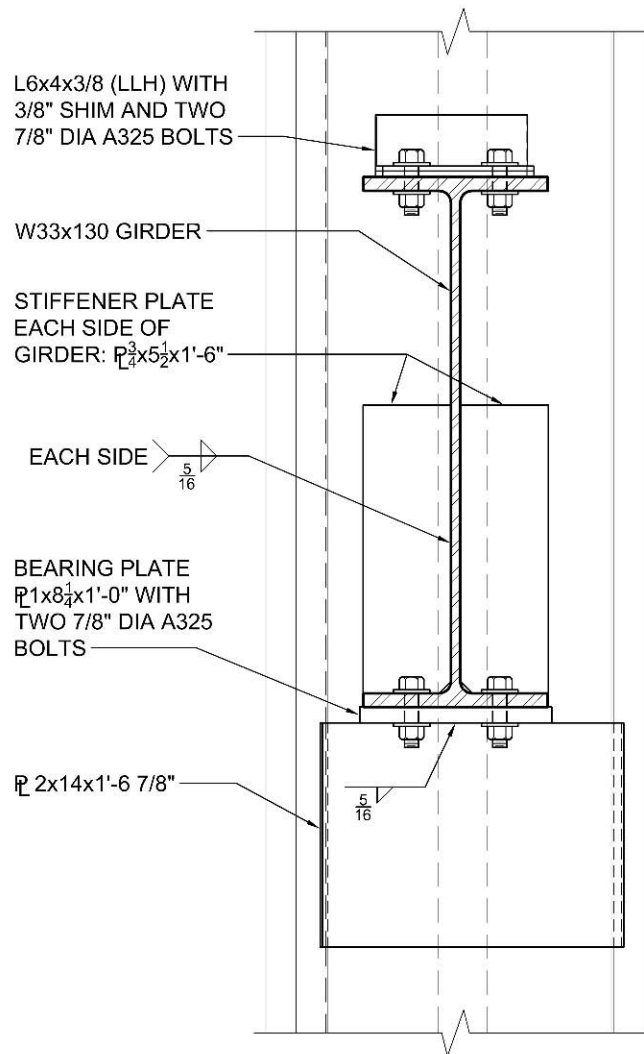
Figure 2: Section View at Floor 13, Column 79 Seated-Beam Connection
 (Data from Frankel Steel Limited, 1985b)

The analytical model for the seated-beam connection at column 79 (McAllister et al. 2008) does not account for the presence of stiffener plates as shown in fabrication drawing 9114 (Frankel Steel 1985b). This drawing illustrates $\frac{3}{4}$ -inch (19 mm) thick partial-height web stiffeners welded to the girder web and bottom flange directly over the bearing surface. Fillet welds connecting the

stiffeners were adequate to transfer the vertical shear from the girder web to the stiffeners, and a lateral displacement of 6.25 inches (159 mm) would not necessarily cause a loss of vertical support. The authors' assumption that the flexural stiffness of the girder bottom flange was "*insufficient to transfer the gravity loads*" is untenable. Why were these stiffeners omitted from the ANSYS connection model when they obviously affect the bending characteristics of the girder bottom flange?
