9/11 – Evidence for Controlled Demolition: a Short List of Observations

Frank Legge (Ph D)
Logical Systems Consulting
Perth, Western Australia.
flegge@iinet.net.au

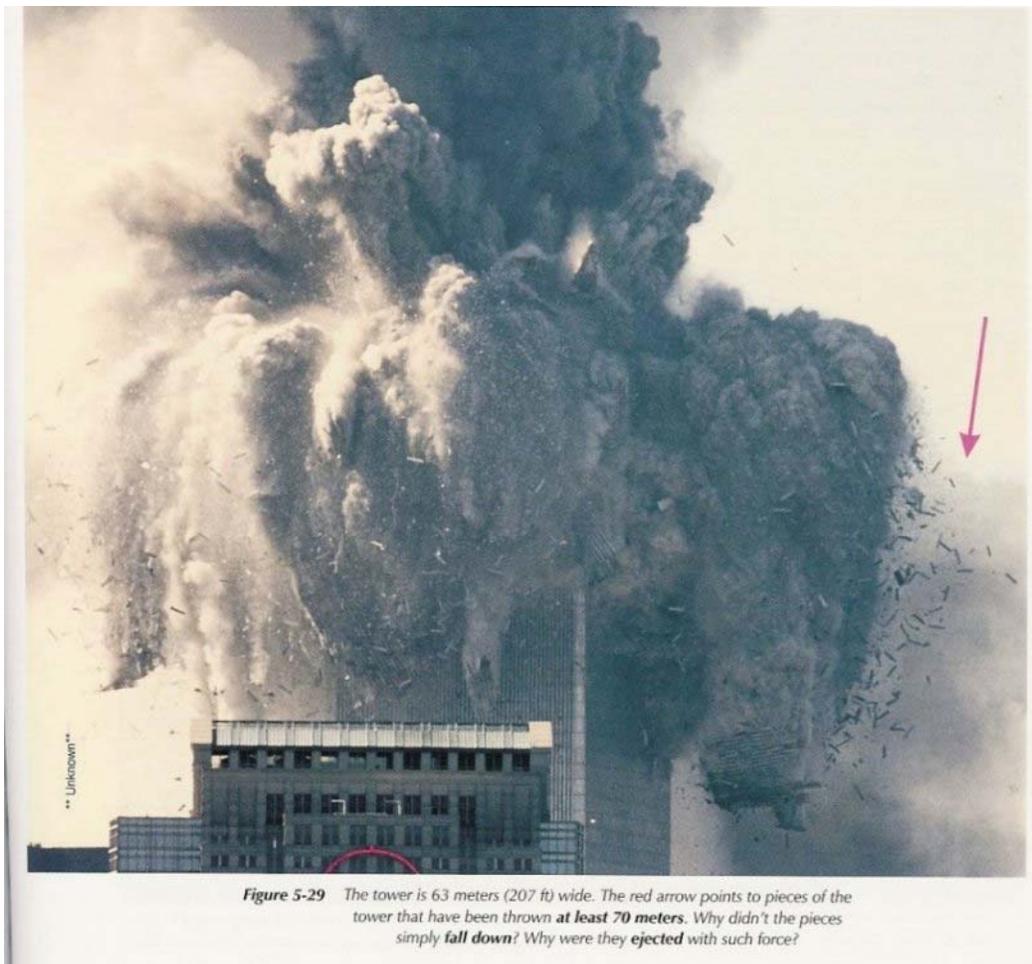
5. Violent projection of dust and steel early in collapse. Of particular interest is the fact that not only does the dust fly out fast very early but also it very quickly falls, showing that it is no ordinary cloud but extremely dense. It is dense because of the very high concentration of concrete in it. Note how the streams of projected dust arch downwards, almost keeping up with the steel. Little concrete was found in the rubble pile. It is not only the pulverization of the concrete which appears to be contrary to normal expectations; one would expect concrete to fracture on impact into large blocks and similarly one would expect the human remains to be substantial. Instead the remains were so severely fragmented that only 12 bodies could be identified visually, 200 samples were found by DNA to have come from one person and 1000 people have not been identified at all.

Notice also that most of the steel flung out appears to be straight. If the building had been destroyed by gravity one would expect much of the steel to be buckled.

The bulk of the steel is below the collapsing region, as would be expected given that the collapse rate is a little slower than free fall, but a piece of steel can be seen about ten floors higher than the collapse region. This requires substantial energy input.

4. During the collapse of WTC 1 and WTC 2 vast clouds of dense dust and portions of the steel columns were violently thrown out.⁵ The dust came mainly from the pulverization of the concrete that was in the floors. The dust cloud and steel were evident early in the collapse, before the parts had picked up much speed, so cannot have come from component impacts. For the pulverization of the concrete, and also to rapidly expand the dust cloud against the pressure of the atmosphere, a very substantial additional source of energy is required. The theory that this energy could have come from the potential energy in the building is clearly untenable as virtually all of the potential energy had to be consumed in providing the kinetic energy for the high downward acceleration, so close to free fall.⁹

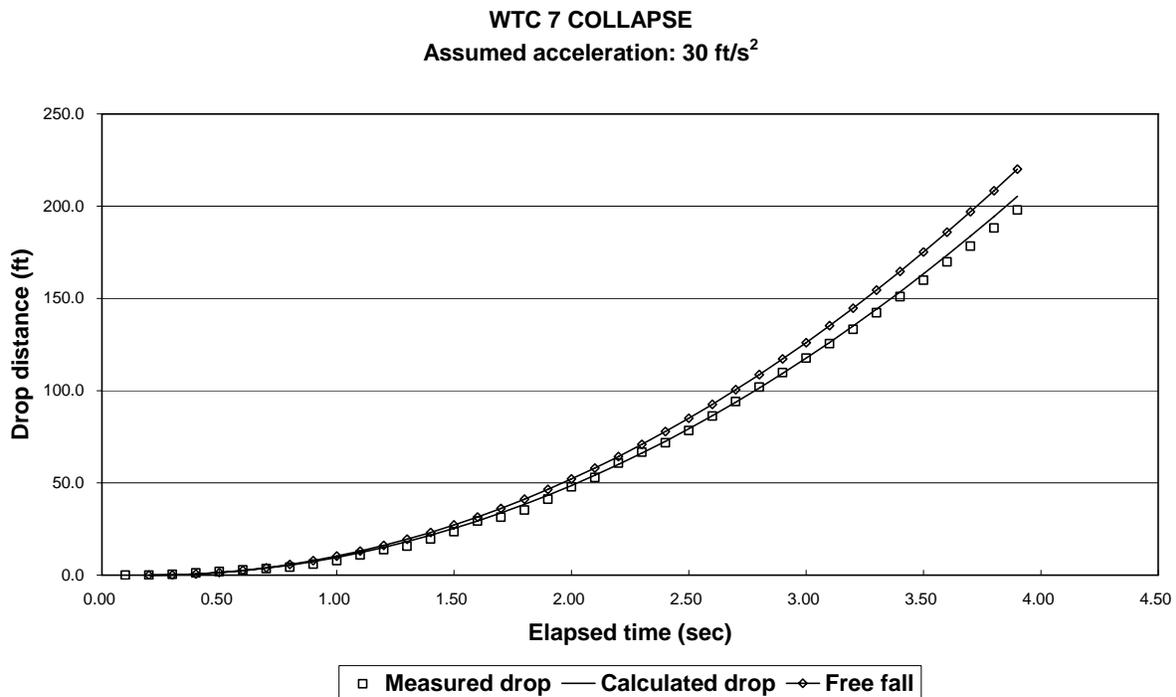
7. Acceleration graph for WTC 7.

It is important to note that when a tall steel column fails under compression it passes through three stages. First it compresses elastically, then plastically, then as the load is increased, or as the temperature is increased, it eventually buckles. Once a buckle has developed the ability to support a load drops but there will still be significant support as the buckle progresses. In the case of a column being heated there will thus be a period, the plastic compressive stage, during which the column nearly supports the gravitational load and movement may not be detectable from a distance. Then, during the buckling phase, there will be an acceleration which will be sufficiently less than free fall for the difference to be easily recognized. If the collapse continued at the rate shown above the total fall time would be 6.2 seconds. Free fall would take 6 seconds.

The line in the graph above is calculated with an equation which assumes constant acceleration, very close to free fall. The measured data points fit this line closely right from the start. There is clearly no sign of a period of lower acceleration corresponding with the buckling phase which would be expected with any theory based on heating of the steel. This implies that something other than heating caused the collapse.

1. WTC 7 collapsed straight down.⁴ This requires that, at the moment of collapse, if caused by fires weakening the supports, not only did the north and south pair of walls have to be of equal strength, but also the east and west pair. Without such symmetry this tall building would inevitably have toppled over. Even if the fires had been intense and widespread this dual symmetry would have only a very low probability of existence. Given the uneven distribution of the small fires at the time of collapse the probability of the required symmetry vanishes, hence fires did not cause the collapse.
2. The acceleration downwards of WTC 7 was 30 feet per second per second. This is so close to the free fall acceleration of 32.2 feet per second per second in a vacuum that

virtually no resistance throughout the fall can have existed. Also the acceleration of WTC 7 was constant right from the start. Steel softens slowly as it is heated and, when just failing, still provides substantial resistance. There was however no sign of the steel giving way gradually as its temperature rose. These two observations, taken together, imply that the support structures were instantly and completely severed.⁷

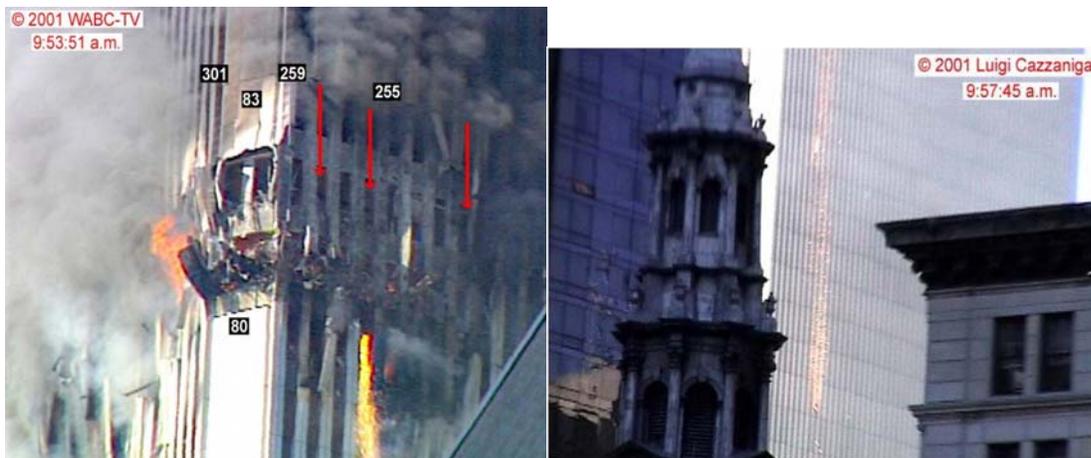
8. Hot metal pours from WTC 2. Also note the shape of the aperture below tag 83. It is symmetrical and the edges are curled outward which indicates an explosion has taken place behind the corner. The clarity of this photograph is damaged in the preparation of the pdf file. For a better view locate it in a web site, for example in the paper by Prof Steven Jones, “Why Indeed Did the WTC Buildings Collapse?”, linked here:

3. A stream of molten metal, yellow-hot and flashing white-hot, was observed running from WTC 2 near the plane impact region.⁸ Shortly after this the building collapsed. When metal is white hot it is at a temperature of at least 1200° C, and when yellow it is at about 1000° C, far hotter than possible from the burning of aircraft fuel or office materials. The use of an oxidizing chemical reaction, such as occurs with thermite, or something similar, is implied. The thermite reaction achieves a temperature well in excess of 2000° C, and produces molten iron as a by-product, melting point 1540° C. It is used to cut steel, melting point about 1500° C.

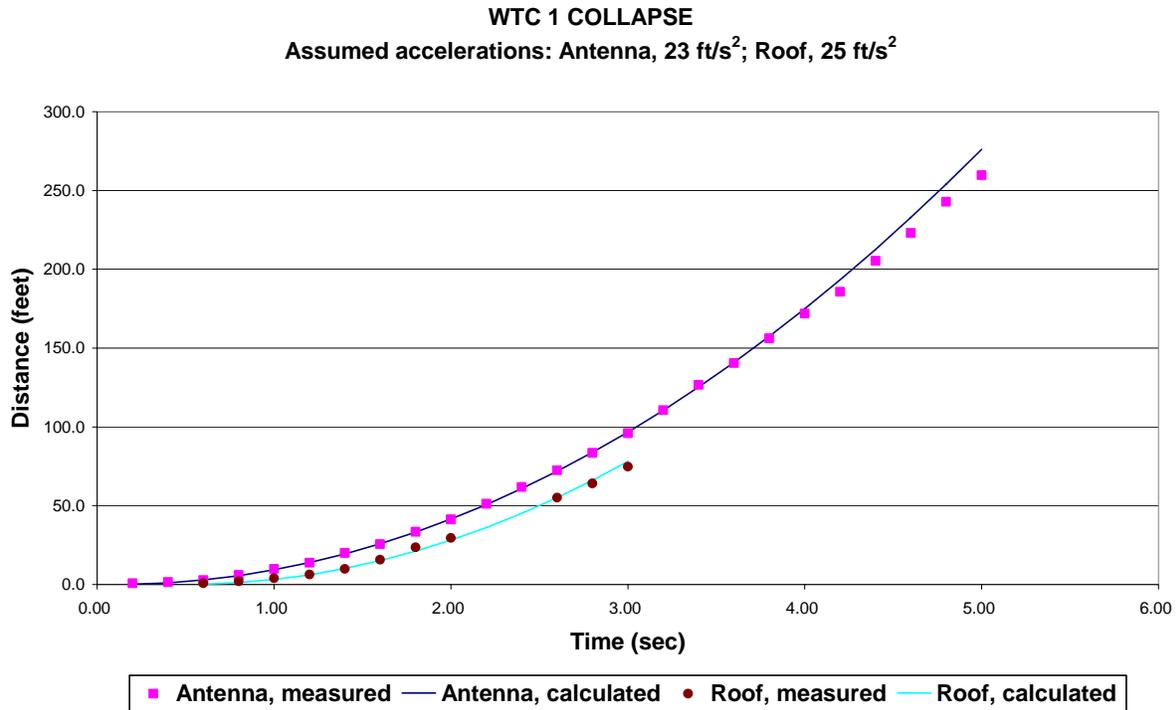
9. Acceleration graph for WTC 1. Note the extremely good fit for the first four seconds to the constant acceleration graph.

As this building was brought down by explosives it would be the timing of the sequence that would determine the rate of collapse and there is no reason why it should necessarily have come down at a speed approaching free fall. The fall was however close to free fall and very uniform at least for the first four seconds. The acceleration apparently declined slightly in the last second before the top of the antenna disappeared into the dust cloud. If the collapse continued at the rate shown for the roof it would be complete in 10.5 seconds, not much longer than free fall, which would take 9.2 seconds.

Allowing all possible approximations in favour of collapse by the official “pancake” model, and allowing all the steel to be in its weakest possible configuration, namely buckled, at 20% of its original strength, and allowing no energy was consumed in pulverizing the concrete or expanding the dust cloud, the fall time comes to 16.3 seconds, substantially longer than the observed rate. This proves the pancake theory is false as it shows each floor had to start moving before it was hit by the one above. This can be explained only by the use of explosives.

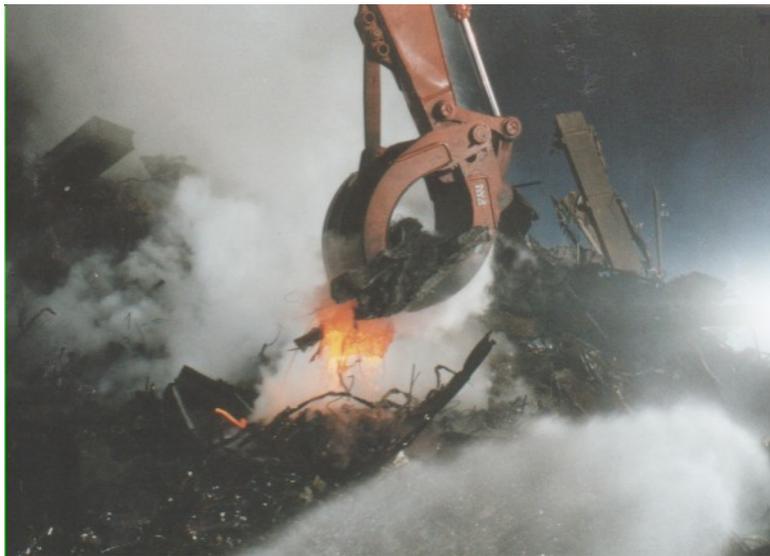
12. Red-yellow hot steel. Photo by Frank Silecchia, taken weeks after the collapse.

Many photographs taken during this period, including the one above, show water being played on the rubble; this produced large clouds of steam. It appears great difficulty was experienced getting the temperature down low enough to enable site clearance to proceed.

1. Weeks after 9/11 workers were still unearthing extremely hot material. A photograph shows solid yellow-hot metal clamped in the jaws of an excavator.¹² The color shows this to be at least 1000° C. This cannot be aluminium, which melts at 660° C, and therefore must be iron or steel. It is impossible for a fire without a dense supply of fuel and forced draft to achieve such high temperatures, hence another energy source must have been involved.

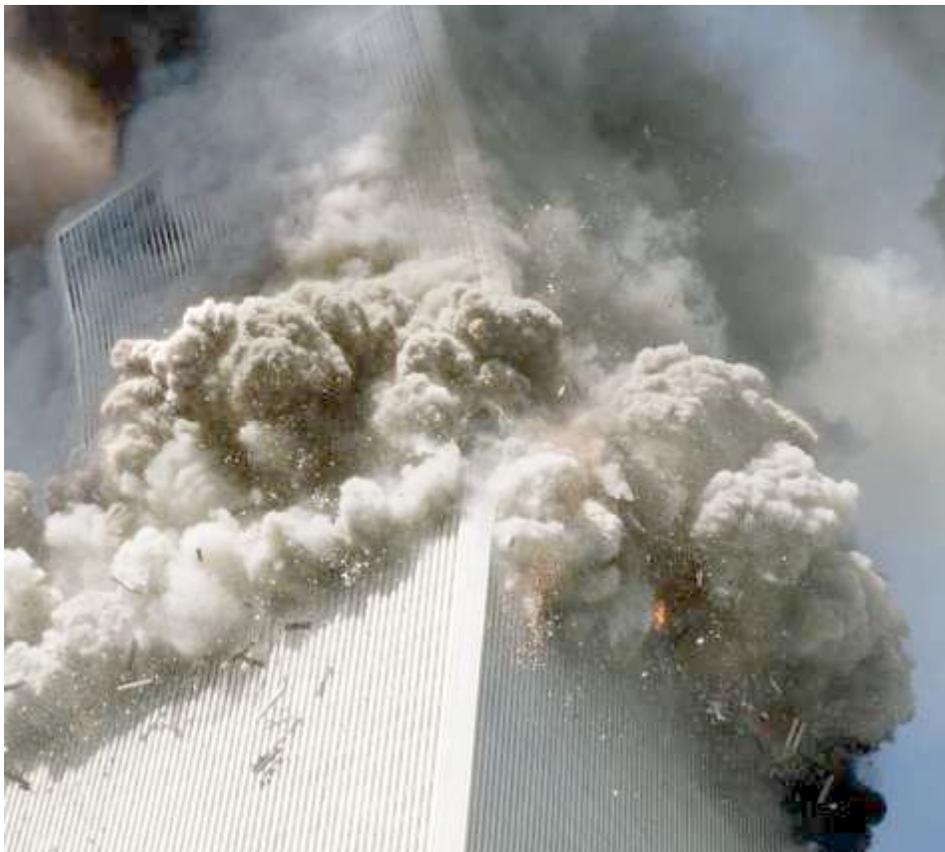
15. This photo by Gulnara Samoiloova contains much important information. Videos show that the top of WTC 2 leans then, within a second, it starts to fall. As it falls it bends, showing that the supports, even high in the building where there is little weight, have already been severed. This photo shows the bend and also catches two rows of horizontal white puffs suggesting demolition charges. The whiteness of the dust being projected suggests the use of thermite as, in addition to molten iron, this produces aluminium oxide, a white powder.

There is also a faint orange glow from material which must be heavy and very hot falling through the dust near the closest corner. This glow will be coming from the intermittent stream of molten metal shown in another photo and video cited earlier.⁸

Many short, straight lengths of steel are already evident at this early stage of the collapse.

The possibility that this photograph has been manipulated to deceive is very remote. It matches the video appearance and there are at least two other photographs from a similar angle showing the distortion in the top.

3. Numerous eye witnesses reported hearing and feeling explosions. Some were injured and some reported being blown off their feet.¹⁴
4. A photograph of WTC 2 shortly after the collapse commenced shows the falling top block distorting, though it was straight just before the fall commenced.¹⁵ As there can be no force acting on the block during free fall, this could not have occurred unless the block had already lost its support structure.
