9/11 – Acceleration Study Proves Explosive Demolition

Frank Legge (Ph D)
Logical Systems Consulting
Perth, Western Australia.
flegge@inet.net.au

Version 2.1

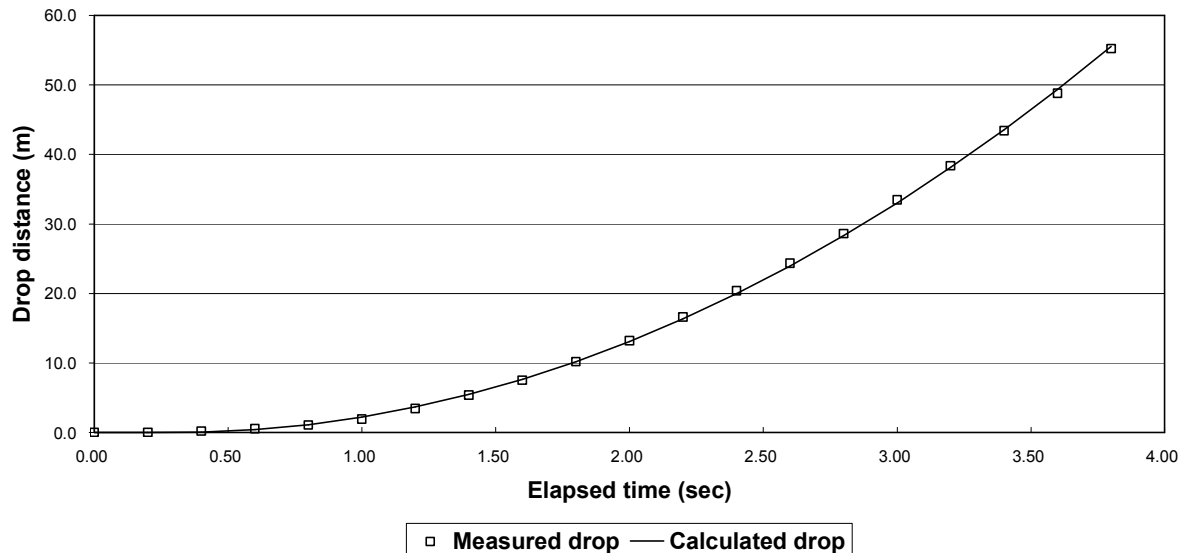
WTC 7 COLLAPSE
Assumed constant acceleration: 9.1 m/s²
Assumed start time: 0.3 seconds

The video on which this paper is based can be viewed at the 911 Research site.⁶ The sag of the roof line can be seen to deepen and widen and spread toward the sides of the building. There is initially negligible motion of the corner nearest the viewer but from the moment it starts to move the collapse of this corner is uniform and close to vertical free fall as shown in the graph below.

The observed acceleration, 9.1 m/s², if maintained, would bring the roof to the ground in 6.2 seconds, very close to free fall in a vacuum, 6.0 seconds. There is no sign of the slow start that would be expected if collapse was caused by the gradual softening of the steel.

The graph above fits the data points closely. The line is drawn with an equation which assumes constant acceleration⁷ and the assumed moment at which the collapse commenced is 0.3 seconds into the displayed elapsed time. As the acceleration is constant the net downward force must have been constant. Gravity is constant which implies that the upward force provided by the structure was also constant. It is inconceivable that fires could heat the structural supports so uniformly throughout the height of the building that the collapse would encounter uniform vertical resistance. Fires by their very nature tend to creep from place to place as they run out of fuel and move to fresh sources, leaving the burnt out area to cool down. Steel regains strength as it cools.

where s is the distance, a is the acceleration and t is the time. The fitting of the equation to the data was done using a least squares method. This gave a value of 9.063m/s^2 , which has been shown to two significant figures in the text and graph.
