The Sustainability of the Controlled Demolition Hypothesis for the destruction of the Twin Towers

Tony Szamboti
Mechanical Engineer

Feb. 17, 2008

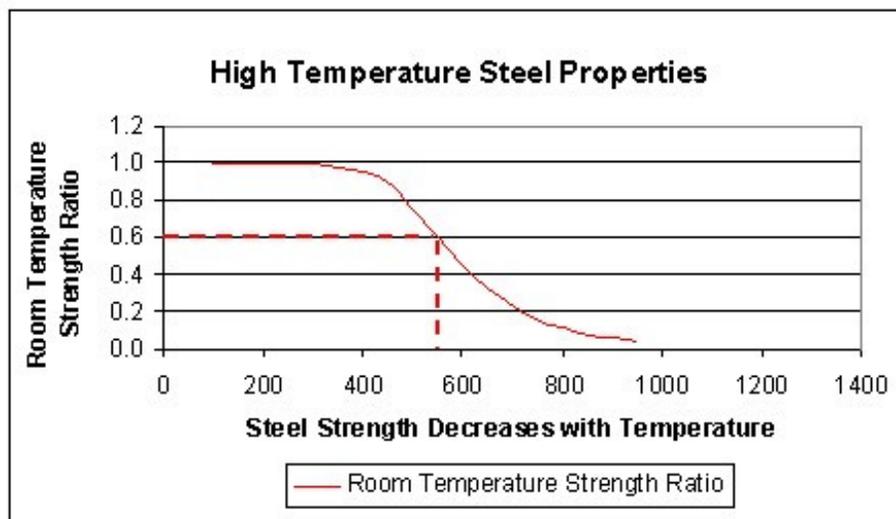
- The towers were designed as virtual structural pyramids, with the wall thickness of the columns being thicker at the bottom and thinning with greater vertical height location due to the changes in loading. Since the tower columns varied in wall thickness, depending on their vertical location, it could be ascertained which columns were in the aircraft impact and fire affected areas. With it being important to know the actual temperatures that the columns experienced, in the fire affected areas, NIST used the known microstructure characteristic of spheroidization to determine those temperatures.⁸ Temperature will change the spheroidization of the steel microstructure in a linear, predictable, and permanent way. In their testing of the steel, from the fire affected areas, NIST found that only a few percent of the tested items ever experienced temperatures above 250° C (482° F) and none above 600° C (1,112° F). None of the central core steel tested showed it had experienced temperatures above 250° C (482° F). The chart below, which shows the proportional loss of strength in steel, as it's temperature is increased, is from Corus Construction, with temperatures in degrees C.

As the chart shows, steel does not lose any of its strength until its temperature rises above 350° C (662° F), and only loses half of it at 600° C (1,112° F). The evidence thus shows that no more than a few percent of the steel structural elements lost any strength due to the fires. While NIST includes this data in their report, it is not discussed in the report's conclusion and is essentially supplanted with an argument,

based on computer modeling, that higher steel temperatures existed, even though there is no physical evidence for it. The amount of jet fuel, which actually entered the towers, can be approximated to be about half of the 10,000 gallons on board each aircraft, due to the fireballs, which erupted on impact. Spreading the remaining 5,000 gallons, in each case, over just one floor of one of the towers (a one acre area), results in a jet fuel layer of approximately .015 feet or 3/16 of an inch. The NIST report admits that this thin layer would have burned up in minutes, leaving nothing more than office materials to fuel the fires. The fact that high temperature effects were not found in the microstructure of the steel should not be surprising.

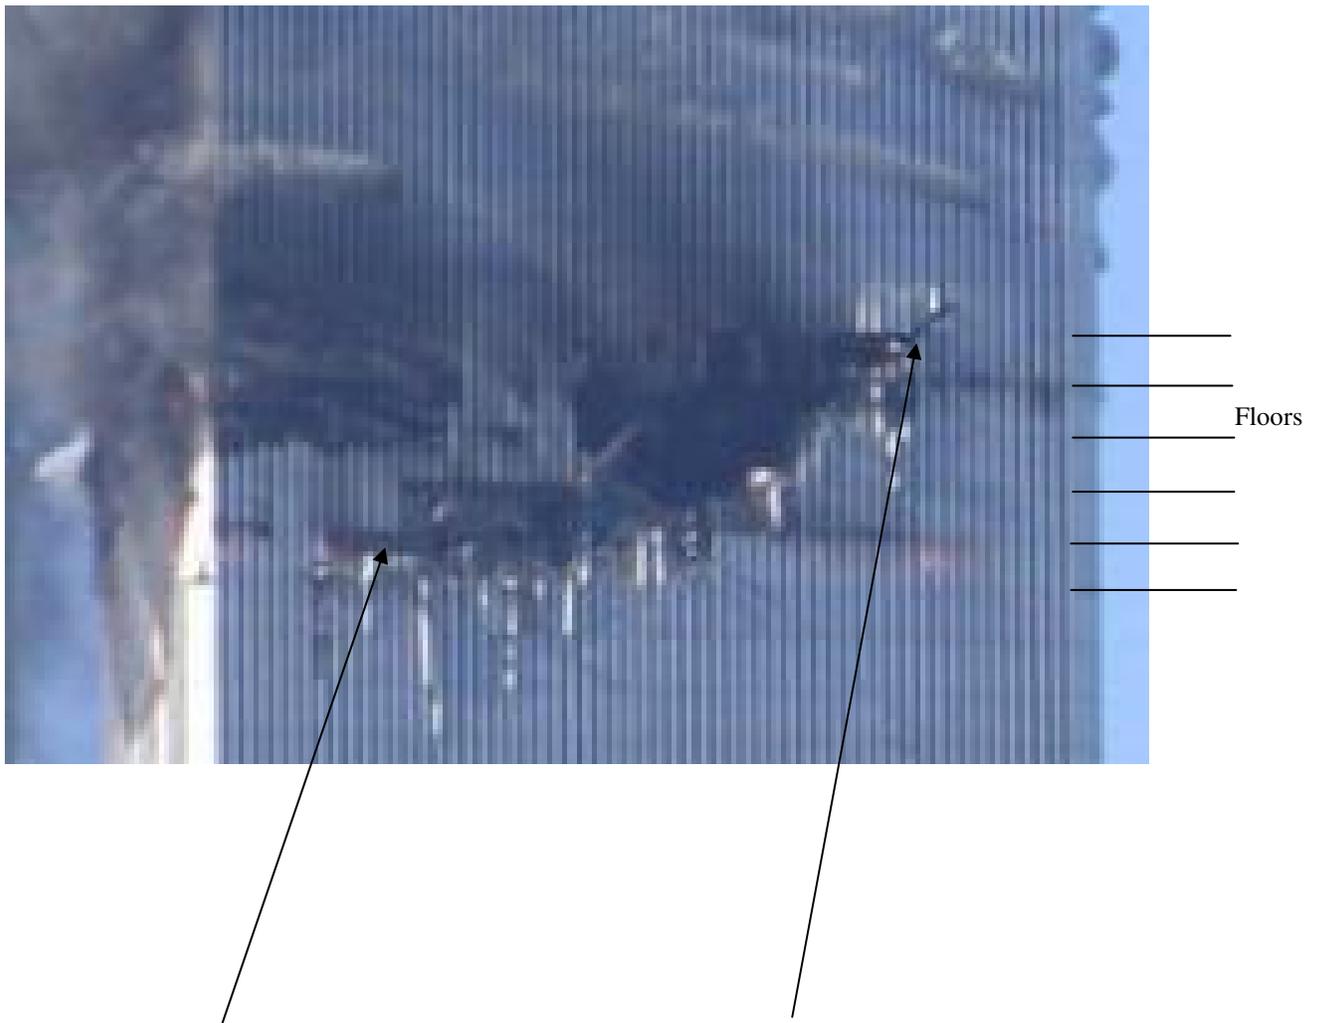
The aircraft impacted both towers at angles to the horizontal on their faces. Here the impact damage to the North Tower is shown exhibiting the angular penetration to the building face. In this case, the wings would have had contact with at least five 4.35 inch thick reinforced concrete floors, in an edge on fashion, after going through the perimeter columns. The vertical portion of the tail would have also had a similar situation due to its height. Note how no full tail imprint is seen and it appears that the tail did not penetrate much past the perimeter.

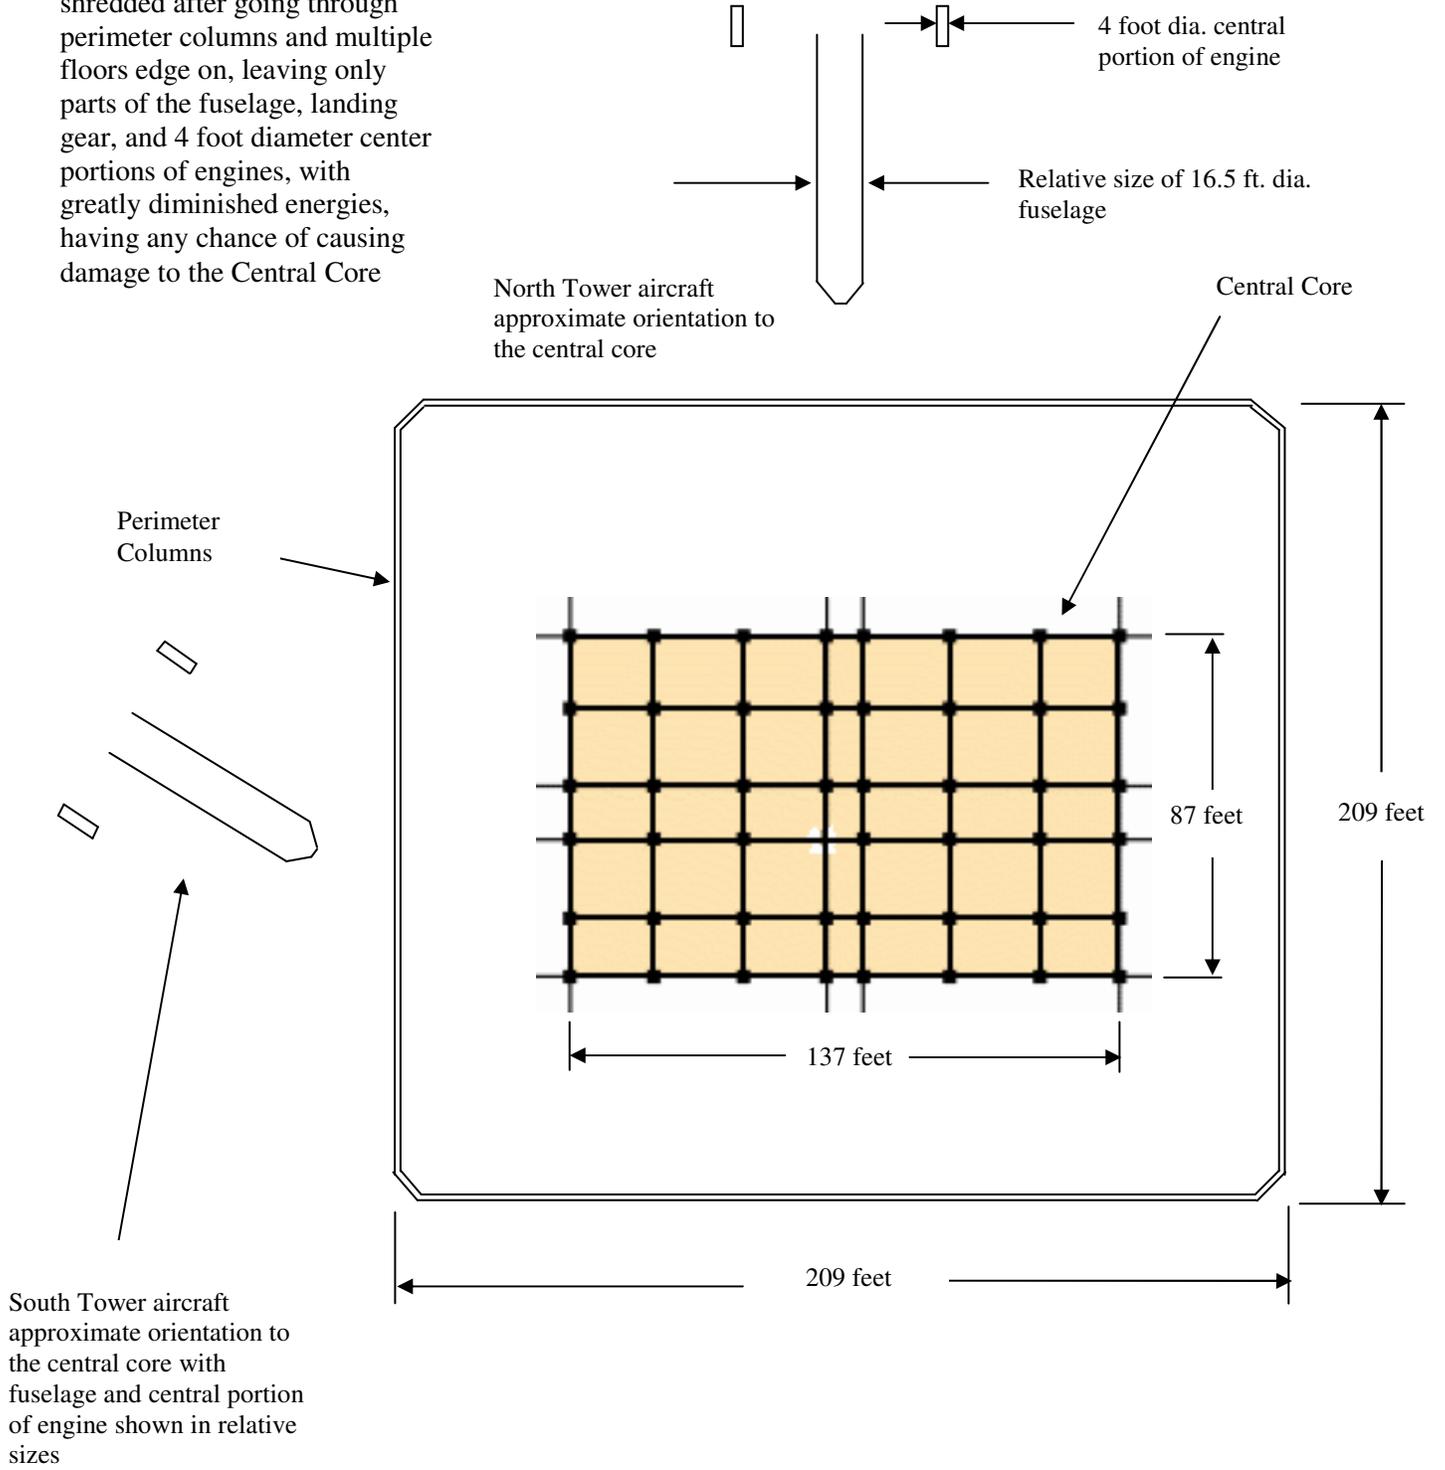
14. Graphic of central core column spacing vs. fuselage and central engine diameters

Wings, engine fan assemblies, and the tail would have been shredded after going through perimeter columns and multiple floors edge on, leaving only parts of the fuselage, landing gear, and 4 foot diameter center portions of engines, with greatly diminished energies, having any chance of causing damage to the Central Core

- Upon impact with the buildings, the wings, tail, and engine fan assemblies of the aircraft would have been shredded prior to completely entering the central core area of the buildings. NIST analyses show this to be probable. This would leave only the fuselage, center portions of the engines, and the landing gear, with greatly diminished energies, to cause damage to the central core columns.^{13, 14} The central cores were comprised of 47 large steel columns interconnected by horizontal beams at every floor in a three-dimensional matrix, encompassing a plan area of 137 feet x 87 feet. The fuselages of both Boeing 767-200ER aircraft, which hit the towers, were 16.5 feet in diameter,⁴ and the center portions of the engines were approximately 4 feet in diameter. The spacing of the central core columns ranged from approximately 11 to 21 feet apart,¹⁴ so by volume alone there would be a limited number of columns, which the remains of the fuselage, engines, and landing gear could contact. The damage to the perimeter columns is visible in photographs and it is known that no more than 20% of the perimeter columns were affected in either tower. It is the damage to the core columns, which was not visible, that needs to be scrutinized. Analyses can be done to show what the remaining energies and volumetric probabilities would be, for impact damage to occur to the core columns. NIST performed analyses of this type and in their nominal or base cases, for both towers, less than 20% of the central core columns were severed or heavily damaged.
