**Discussion of**

**“Spontaneous Collapse Mechanism of World Trade Center Twin Towers and Progressive Collapse  
in General” by Jia-Liang Le and Zdeněk P. Bažant**

Jonathan H. Cole, P.E., M.ASCE

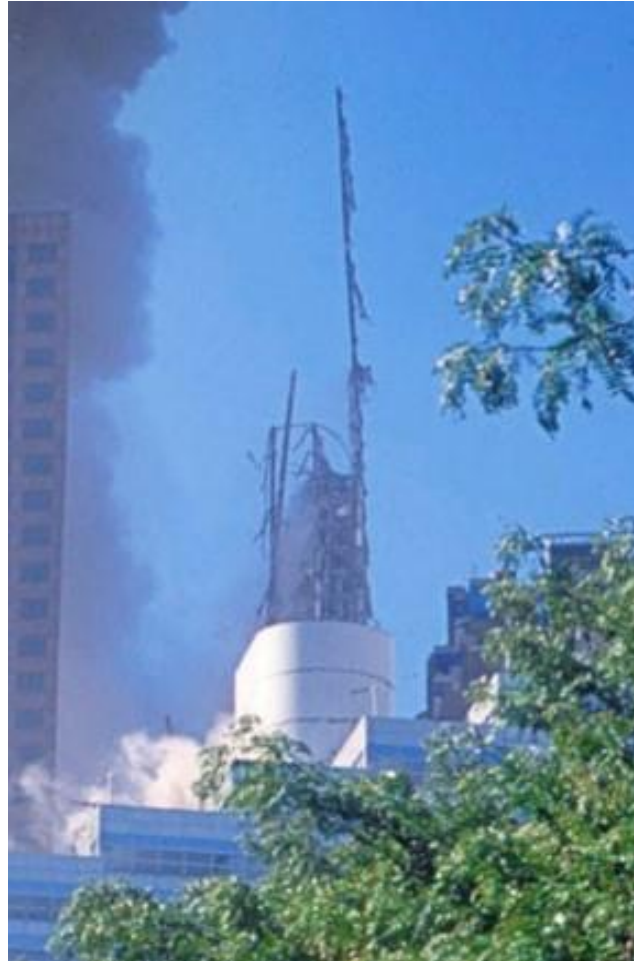
A remaining unbent group of inner core columns stands for a significant time. The photograph taken by Lyle Owerko (permission granted) presented in Fig. 1 clearly shows this group of inner core columns. Since the roof (or its fragments) fell in Stage Two, the highest point of the tower is now represented by the standing core columns. No downward nor lateral ejection of debris is observed for the entire duration of Stage Three.

**Fig. 1.** Standing core columns. Image courtesy of Lyle Owerko.

The upper part and roof system could not have passed down through the standing core structure and remained intact. Since the upper part could not pass down through the standing core structure intact, then its components could not have acted as a unified mass, invalidating the underlying assumptions of the Technical Paper.

Le and Bažant suggested the upper part was obscured by dust clouds after the first few seconds. However, given the large quantity of video and photographic evidence from many angles showing no upper part whatsoever as well as the existence of the standing core structure, it is likely that the upper part was fragmented prior to any crush-up phase rather than simply obscured by dust clouds. The still-standing core column structure in Stage Three would also inhibit any crush-up phase.

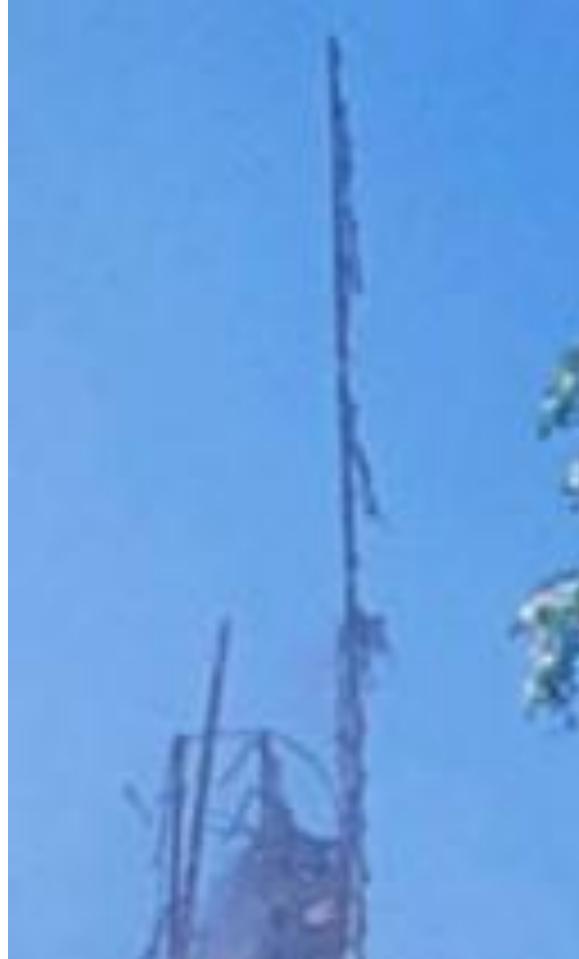
**Fig. 2.** Standing core column. Image courtesy of Lyle Owerko.

There is a particularly tall core column at the top of the standing core group shown in Fig. 2. What was once a braced column is now unbraced, with its top free during this stage, resulting in a much longer effective length. Because of the large slenderness ratio, the downward force on it must have been significantly *less* than its design capacity during Stage Two of the collapse process, or the column would be buckled and bent. Therefore, there could not have been any significant downward force imposed by any falling upper part or roof system on that column, nor on the other free-standing group of core columns.

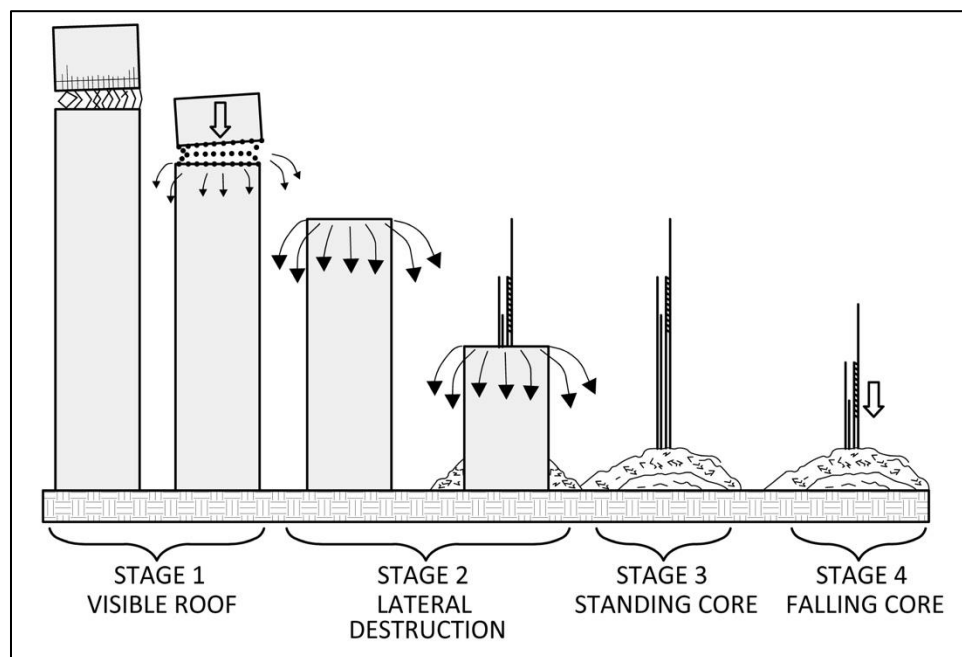
The Technical Paper included a “*Schematic of the collapse process of WTC towers.*” The schematic omitted the latter two stages of the entire collapse process. In addition, it did not indicate the standing inner core structure. A more accurate representation of the entire collapse process is shown in Fig. 3.

**Fig. 3.** Schematic of the collapse process of the North Tower.

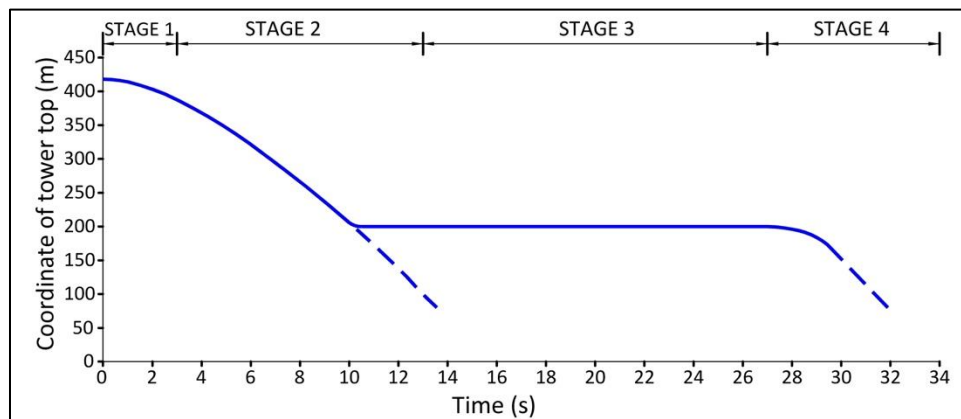
Similarly, the Technical Paper's graph entitled "*Motion histories of the towers for the entire collapse duration*" did not include the motion history of the entire collapse duration of approximately 30 seconds. Since the standing core structure and its subsequent fall were omitted, any claim of the modeling representing the entire collapse duration is inaccurate, invalidating the current mathematical model. A more realistic motion history graph for the entire collapse is presented in Fig. 4.

**Fig. 4.** Approximate motion history of the North Tower for the entire collapse.
